Manhole Inspection Summary

Manhole # S15G1_013MH

Location Address: **3051B gable-patapsco industrial complex**

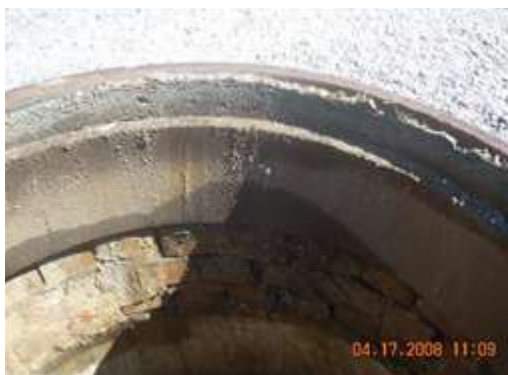
misc.

inflow evidence

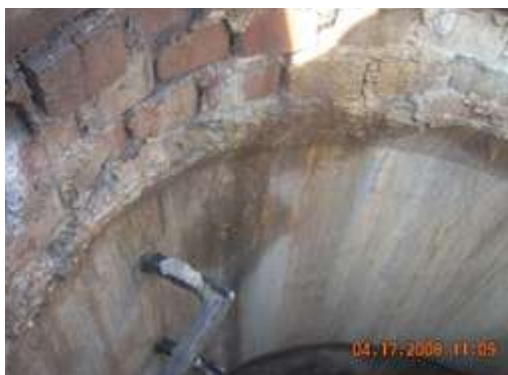
Defect 2

Infiltration: ☐ None ☒ **Joint** ☐ Cracks ☐ Mortar ☐ Roots ☐ Wall

infiltration @ chimney/corbel joint

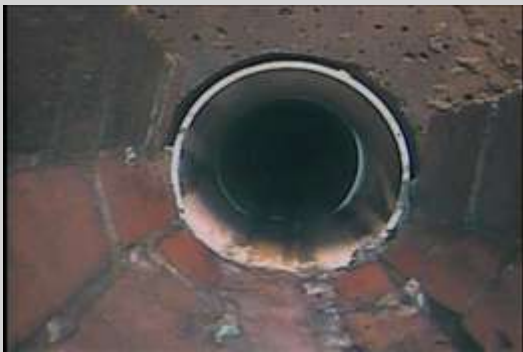
12 O'Clock Outflow

8 in. Circular Gravity Sewer
Pipe Out @ 12 O'Clock

Pipe Height: **8.4** (in.) Rod and Bar (Angled)
Pipe Material: **PVC** ☐ Pipe Lined
Invert Depth: **8.20** (ft.) Flow Characteristics: **Slow**
Deposits: ☒ None ☐ Mud ☐ Sludge ☐ Debris ☐ Grease
Silt Depth: **0** (in.) Deposits Extent:
Infiltration: **None** Pipe Seal Cond: **Sound**

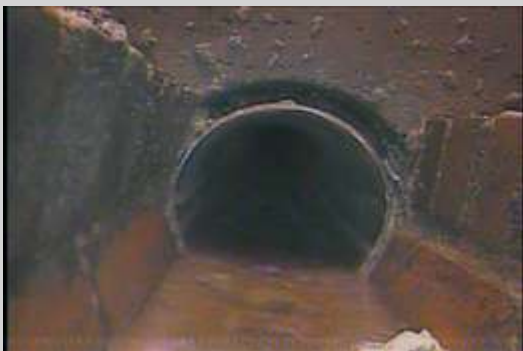
6 O'Clock Inflow

8 in. Circular Gravity Sewer
Pipe In @ 6 O'Clock

Pipe Height: **8.4** (in.) Rod and Bar (Angled)
Pipe Material: **PVC** ☐ Pipe Lined
Invert Depth: **8.15** (ft.) Flow Characteristics: **Slow**
Deposits: ☒ None ☐ Mud ☐ Sludge ☐ Debris ☐ Grease
Silt Depth: **0** (in.) Deposits Extent:
Infiltration: **None** Pipe Seal Cond: **Sound**
